U. S. NAVY SUPPLY OFFICE-SCHOOL
NAVAL SUPPLY DEPOT, BAYONNE, NEW JERSEY

NAVY REPORT SERIAL NO. NT-003-010

PROJECT REPORT NO. 2.4190

DEVELOPMENT OF SHORE PARTY EQUIPMENT
(STEEL WIRE PALLETS)

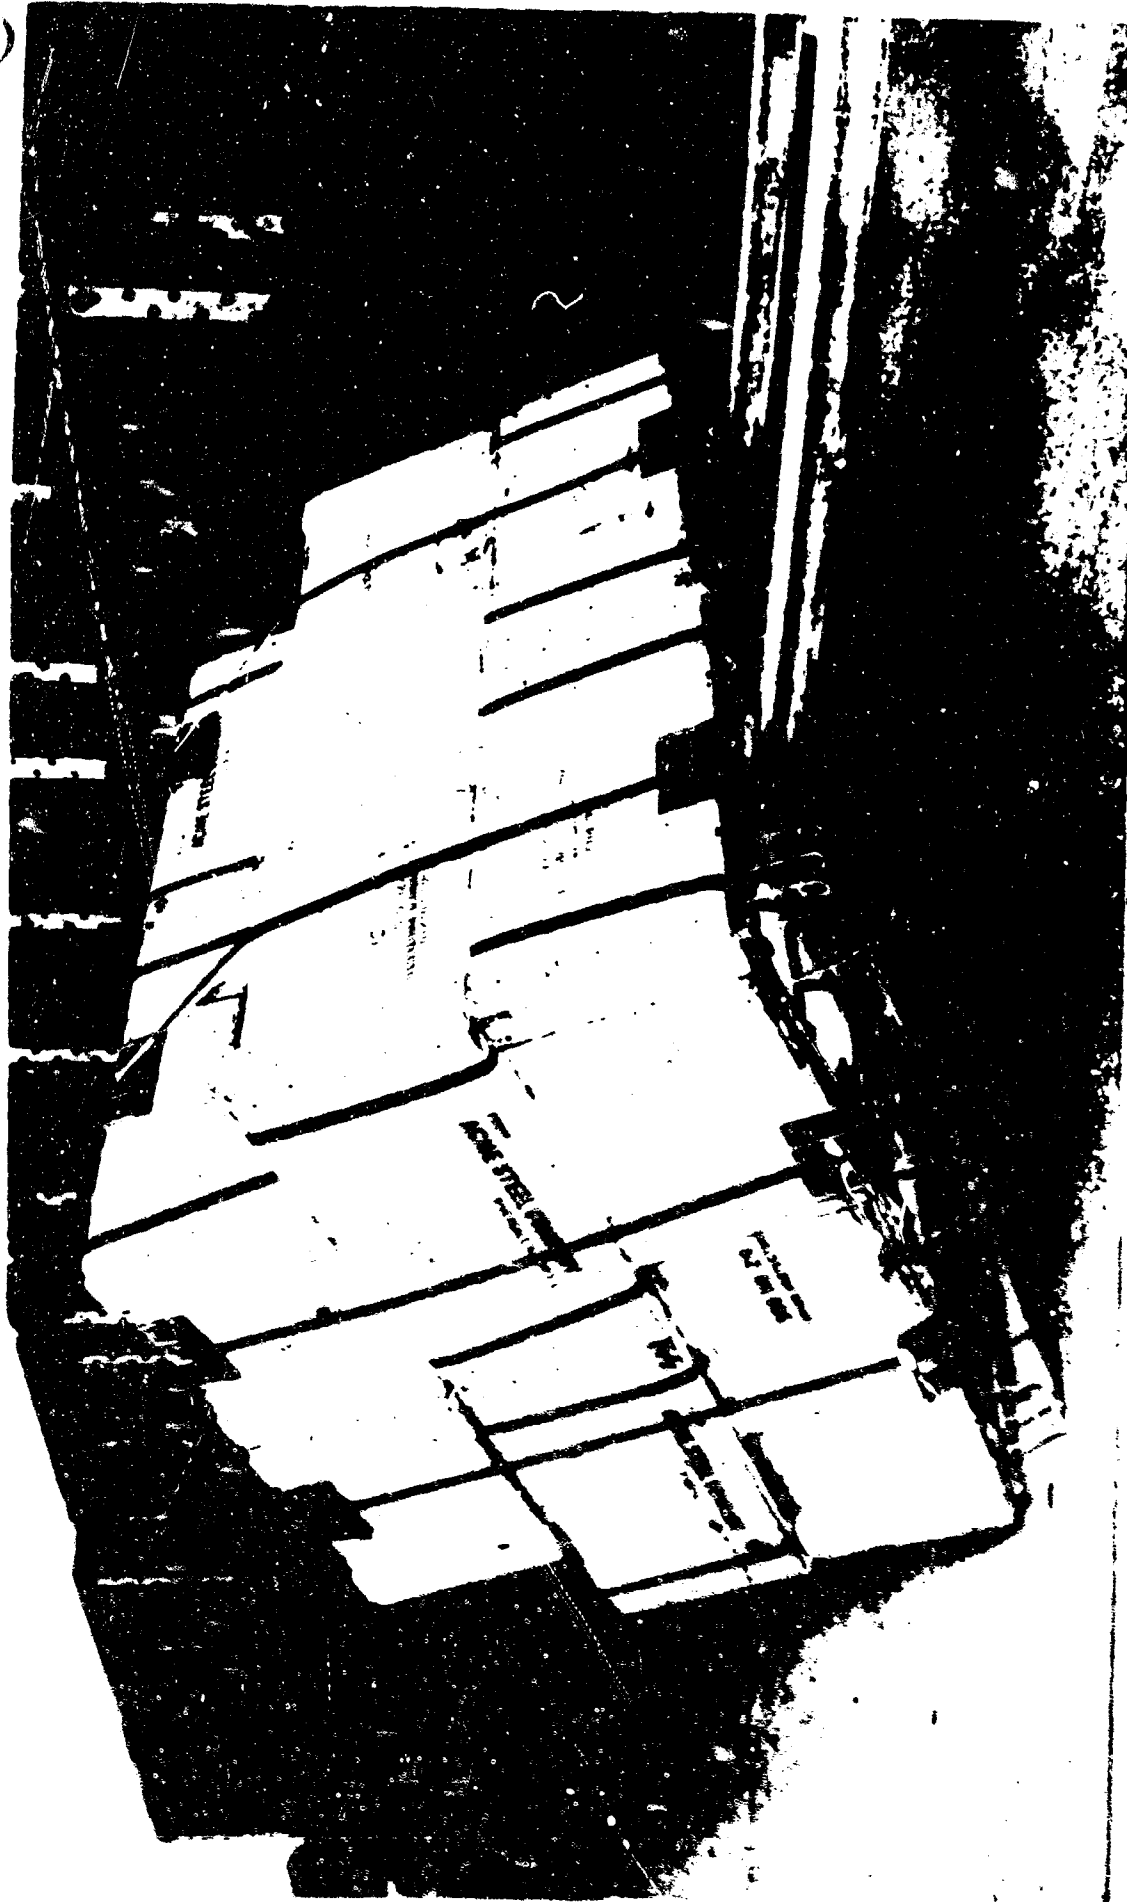
(1) The Steel Wire Pallet (Fibreboard Deck) cracked and broke through when the first box was dropped to the pallet deck by the warehouse

ILLUSTRATION OF TEST CONDITIONS FOR TEST #6,
STEEL LOADING.

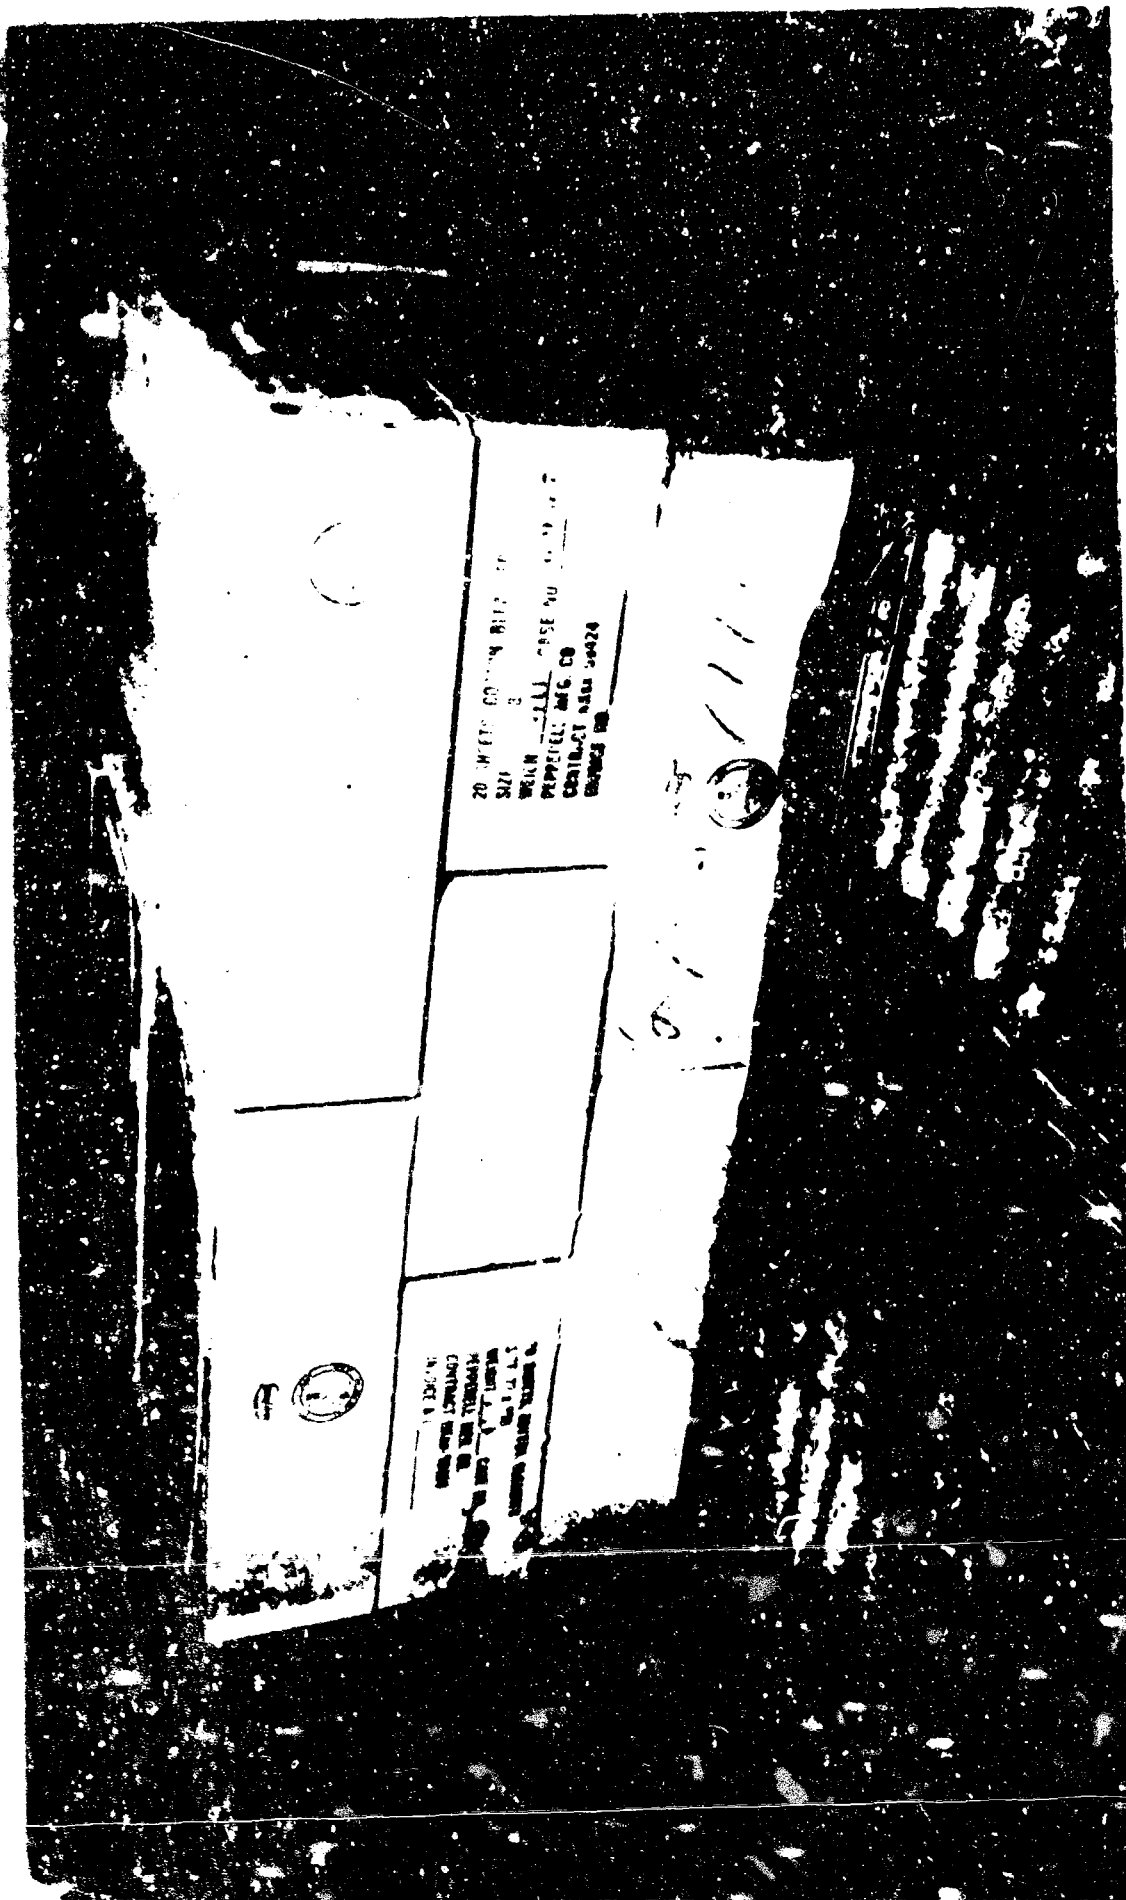
When movement by wood rollers was attempted it was found that when the 3" wide ribbed plates on the bottom of the pallet were placed at right angles to the wood rollers, such plates showed a tendency to deflect but movement could be made although difficulty was experienced in inserting new rollers at the forward end of the pallet. When such pallet bottom plates were placed parallel to the wood rollers, the full weight of the loaded pallet was born by the cross wires which were not sufficiently rigid to withstand the load and failure of the pallet resulted as indicated by Photo #104-0, Page 91.

ILLUSTRATION OF ROLLER CONVEYOR METHOD OF
MOVEMENT WITH STEEL WIRE PALLETS POSITIONED
WITH THE 3" WIDE BOTTOM PLATES AT RIGHT ANGLE
TO THE ROLLERS.

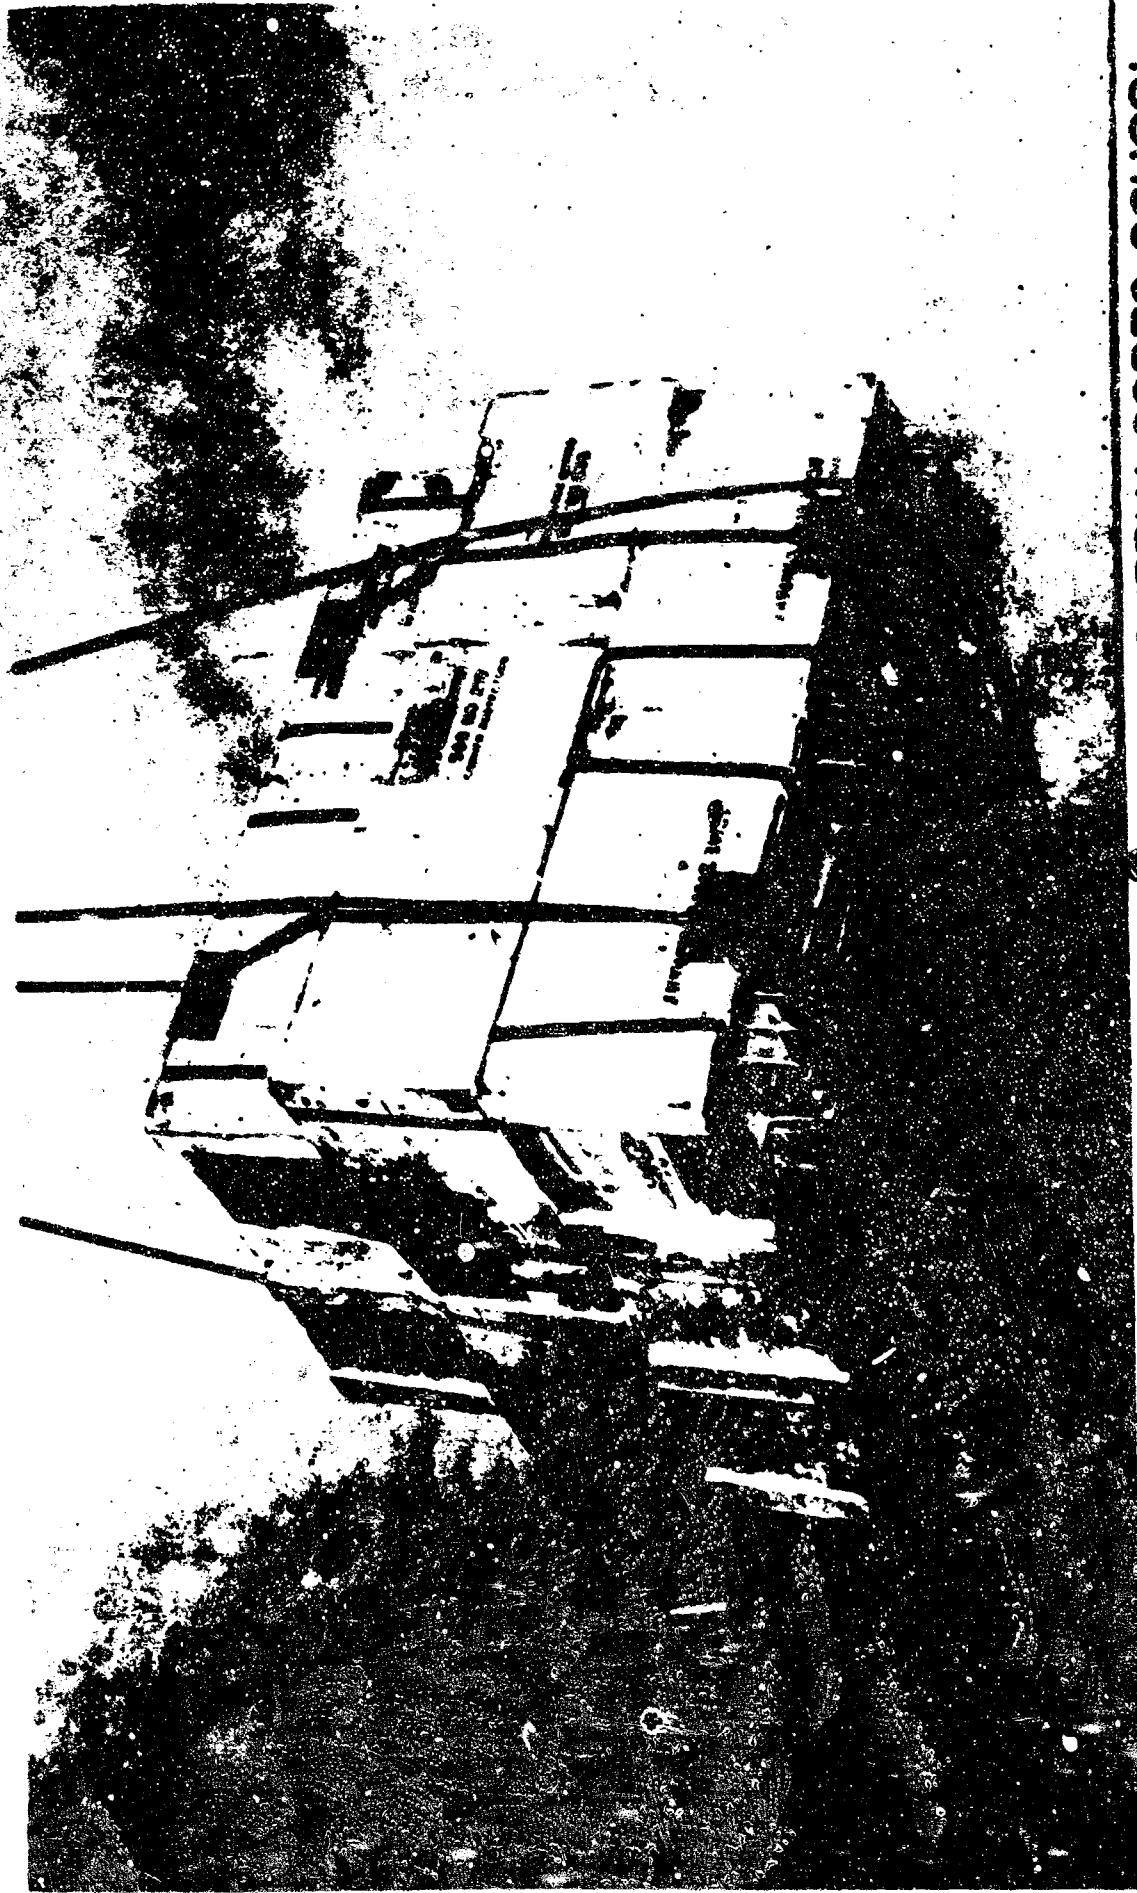
Condition #1 (Drop Test) - One loaded pallet of each type was rigged and suspended by means of a conventional wire cable wrapped under the 3" overhanging wing of the top deck on two sides of the pallet. Such rigging and general condition of the load previous to test is indicated by Photo #42-14, Page 318. As a preliminary precaution the wire sling was first placed inside the vertical posts of the pallet but this was

CONDITION OF FIBERBOARD DECK PALLET LOADED
WITH 3,500 LBS. PRIOR TO DROP TEST WITH
BLINDS PLACED UNDER THE PALLET.

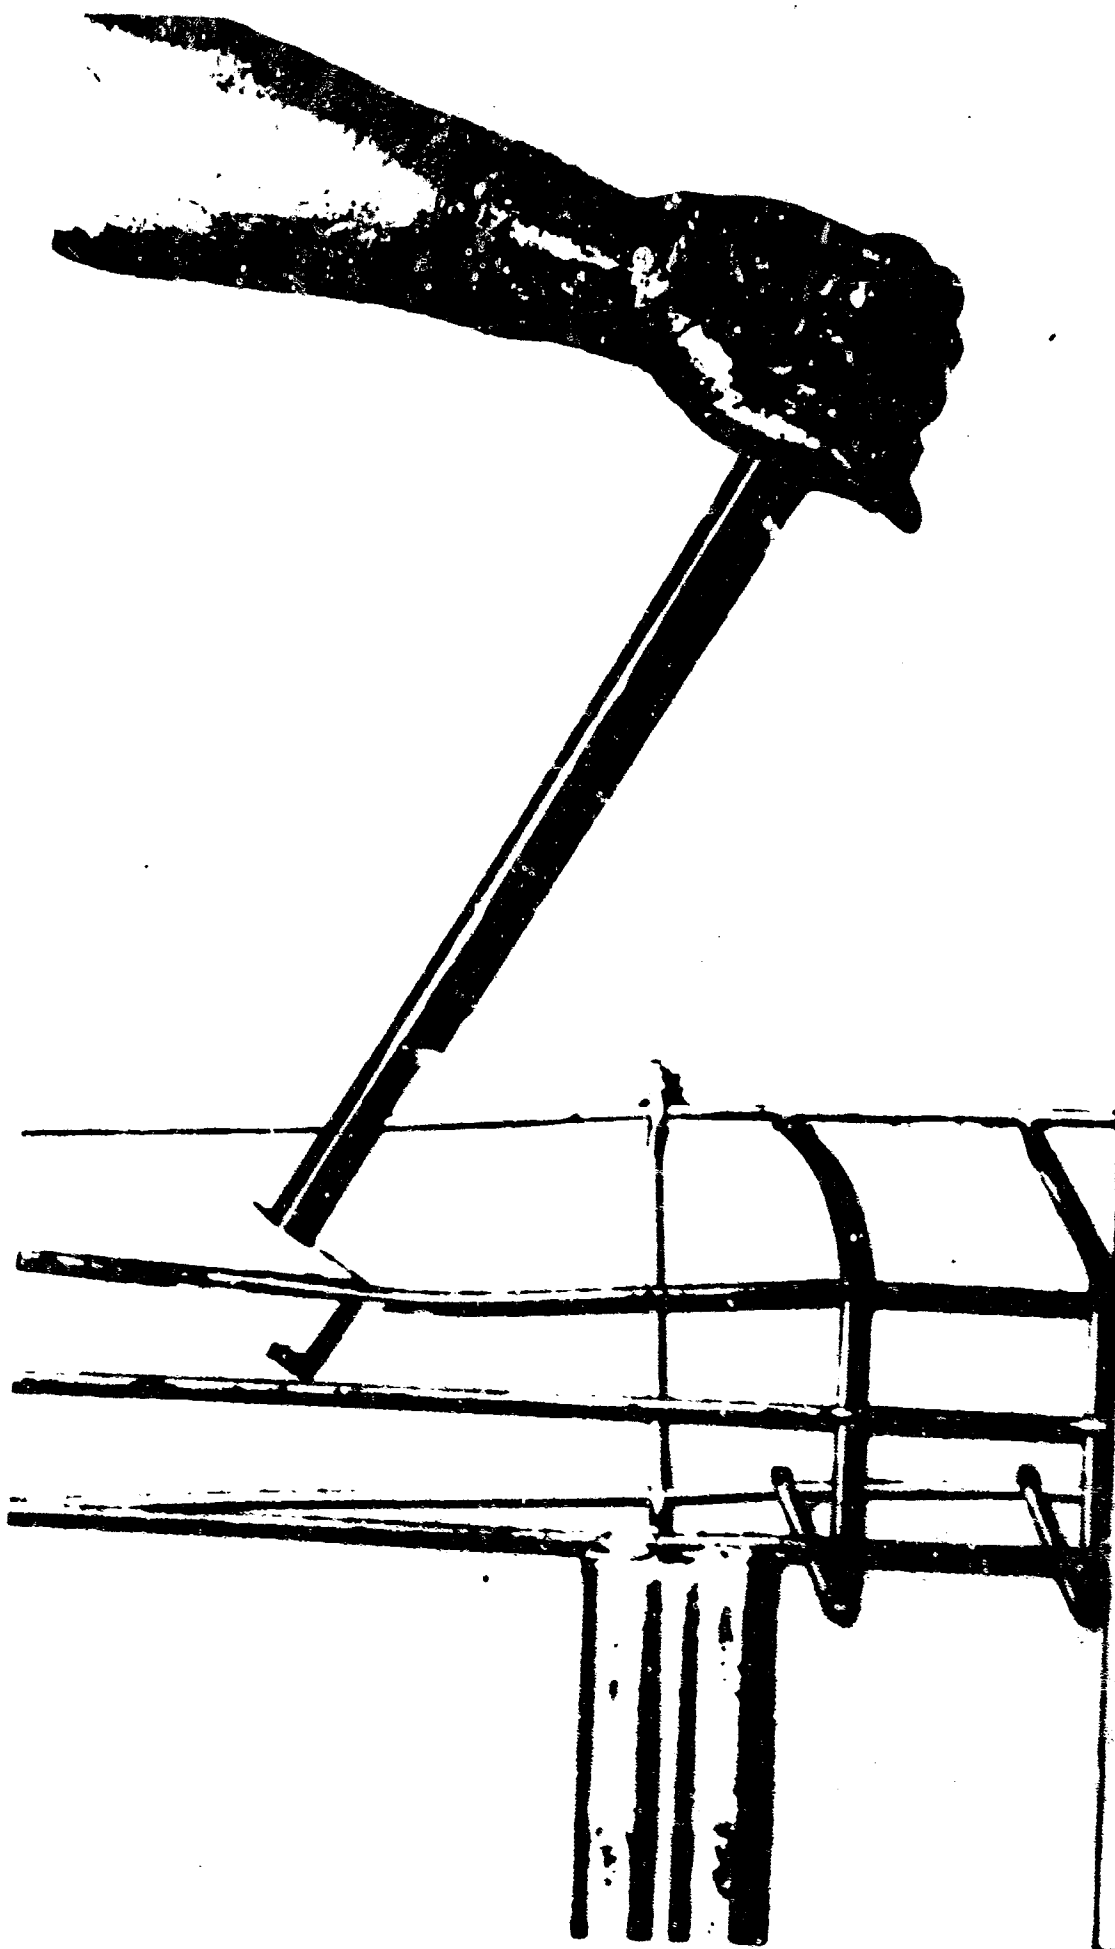
ILLUSTRATION OF THE STRAIGHTENING TOOL SET-UP
FOR BENDING BIRMINGHAM. TOOL NOT ADAPTABLE FOR
BENDING OTHER BIRMS.

Both types of pallets do not permit rapid disassembly when repairs are necessary. To properly replace damaged parts of the pallet; the services of a skilled welder with suitable equipment is required, together with replacement parts. The use of the Steel Wire Pallet (Fibreboard Deck) is not at all practical due to easy fracture of the deck during normal operations.

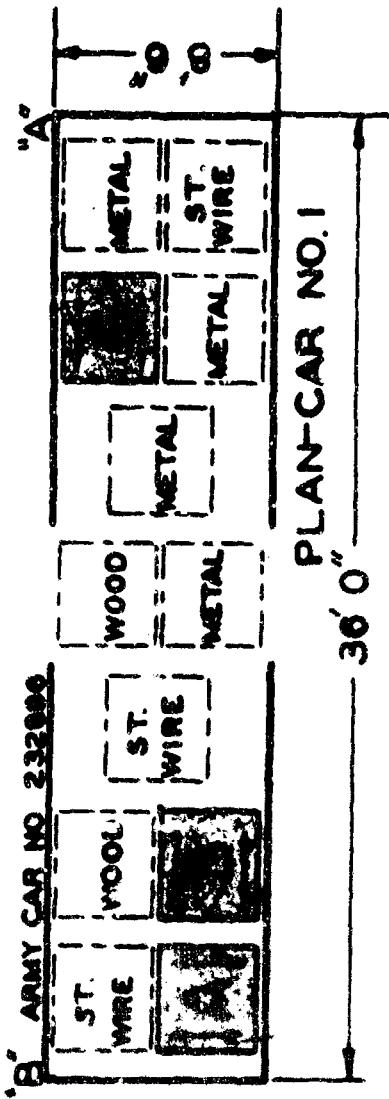
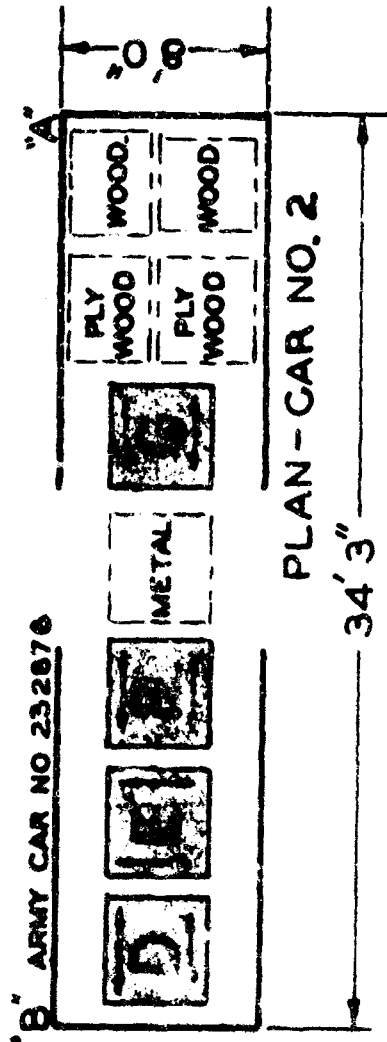
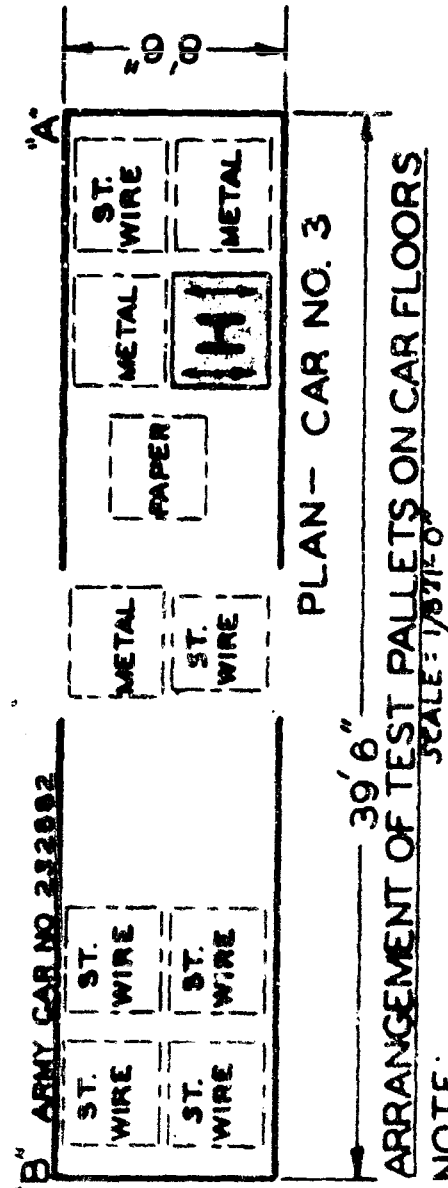
PALLET "G" - STEEL WIRE PALLET (FIBREBOARD DECK)
Condition fair. Deck was cracked previous to fire.

PALETTE "H" - STANDARD NAVY WOOD PALLET
in condition good. Pallet was used in Depot work.
